# Reinspection Survey

FX0001132  
Crosby Ravensworth CE School  
Crosby Ravensworth  
Penrith  
Cumbria  
CA10 3JJ

| Project Number: | J025428 | | |

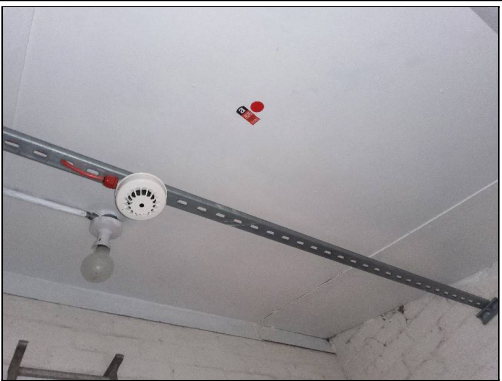
| | Re-inspection Date: | Lead Surveyor | Survey Type | Floor | Analysis |
|---|---|---|---|---|---|
| | Crosby Ravensworth CE School | Non Teaching Store - AG014 | Cement panels to ceiling beams and wall | 4m <sup>2</sup> | |
| | As LM000490 | Asbestos Cement (1) | Surface Sealed (1) | Good Condition (0) | Usually inaccessible or unlikely to be disturbed (0) |

| Normal Occupancy | Score | Likelihood of disturbance | Score | Exposure Potential | Score | Maintenance Activity | Score |
|---|---|---|---|---|---|---|---|
| Combined Score: | 8 | | | | | | |

| Normal Occupancy | Score | Likelihood of disturbance | Score | Exposure Potential | Score | Maintenance Activity | Score |
|---|---|---|---|---|---|---|---|
| Recommendation | Manage and re-inspect | | | | | | |

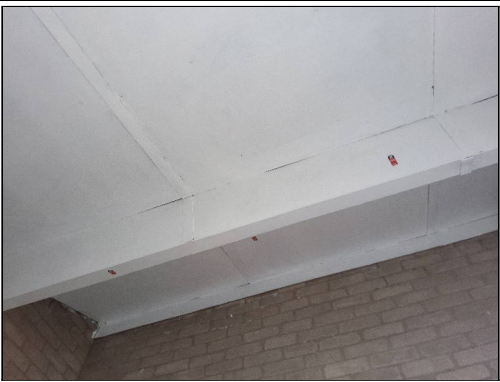
| | Re-inspection Date: | Lead Surveyor | Survey Type | Floor | Analysis |
|---|---|---|---|---|---|
| | Crosby Ravensworth CE School | Oil Store - AG015 | Cement panels to ceiling beams and wall | 6m² | |
| | As LM000490 | Asbestos Cement (1) | Surface Sealed (1) | Good Condition (0) | Usually inaccessible or unlikely to be disturbed (0) |

| Normal Occupancy | Score | Likelihood of disturbance | Score | Exposure Potential | Score | Maintenance Activity | Score |
|---|---|---|---|---|---|---|---|
| Combined Score: | 7 | | | | | | |

| Normal Occupancy | Score | Likelihood of disturbance | Score | Exposure Potential | Score | Maintenance Activity | Score |
|---|---|---|---|---|---|---|---|
| Recommendation | Manage and re-inspect | | | | | | |

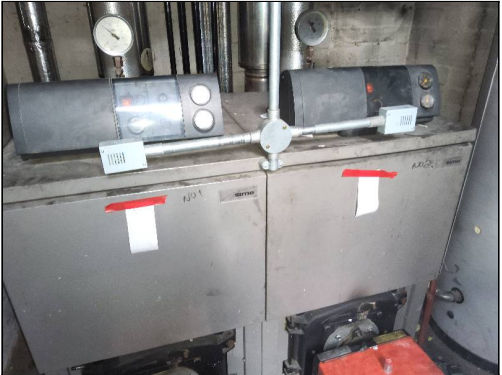
| | Crosby Ravensworth CE School | Boiler House - AG016 | Presumed woven materials within Sime boiler units - not accessed to sample as live. | 2no. | |
| | P | Asbestos Textiles/Paper (2) | Unsealed (2) | Good Condition (0) | Usually inaccessible or unlikely to be disturbed (0) |

| <b>Combined Score:</b> | 9 | | | | | | |

| <b>Recommendation</b> | Inspection required | | | | | | |

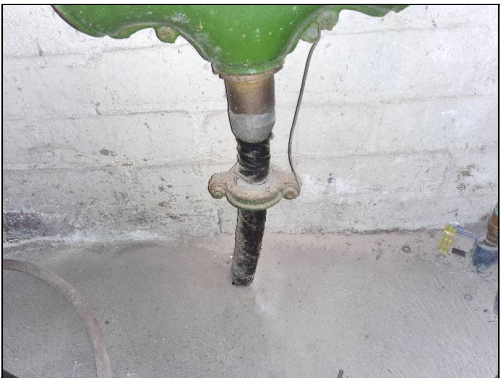
| | Crosby Ravensworth CE School | Boiler House - AG016 | Bitumen wrap to electrical cable - unable to sample for health and safety reasons | 1lm | |
| | P | Reinforced Composite (1) | Completely Sealed (0) | Low Damage (1) | Easily disturbed (2) |

| <b>Combined Score:</b> | 8 | | | | | | |

| <b>Recommendation</b> | Inspection required | | | | | | |

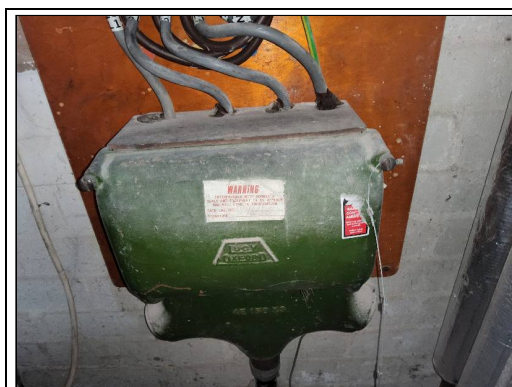
| Re-inspection Date: | Lead Surveyor | Survey Type | Floor | Analysis |
|---|---|---|---|---|
| P | Asbestos Textiles/Paper (2) | Unsealed (2) | Good Condition (0) | Usually inaccessible or unlikely to be disturbed (0) |

| Normal Occupancy | Score | Likelihood of disturbance | Score | Exposure Potential | Score | Maintenance Activity | Score |
|---|---|---|---|---|---|---|---|
| Recommendation | Inspection required | | | | | | |

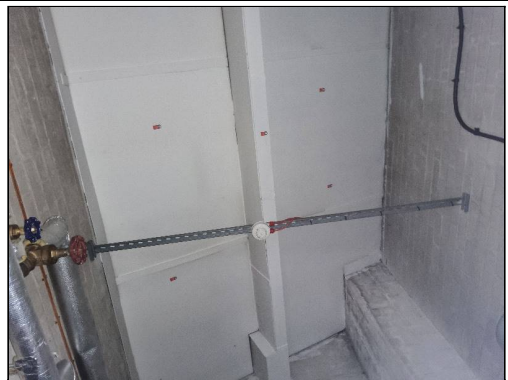
| | S LM000490 | Asbestos Cement (1) | Surface Sealed (1) | Good Condition (0) | Usually inaccessible or unlikely to be disturbed (0) |

| <b>Recommendation</b> | Manage and re-inspect | | | | | | |

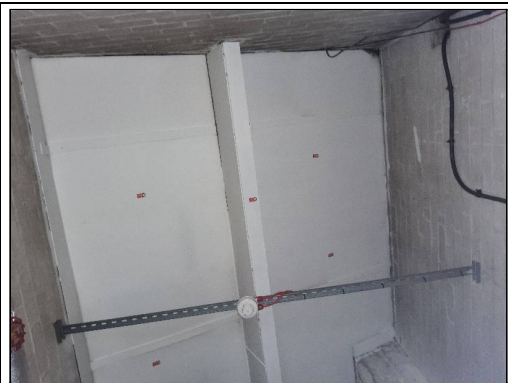
| | Re-inspection Date: | Lead Surveyor | Survey Type | Floor | Analysis |
|---|---|---|---|---|---|
| | S LM000491 | Asbestos Insulating Board (2) | Surface Sealed (1) | Low Damage (1) | Usually inaccessible or unlikely to be disturbed (0) |

| Normal Occupancy | Score | Likelihood of disturbance | Score | Exposure Potential | Score | Maintenance Activity | Score |
|---|---|---|---|---|---|---|---|
| Recommendation | Manage and re-inspect | | | | | | |

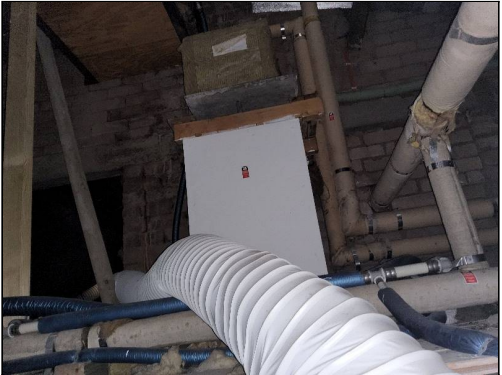
| | S LM000487 | Asbestos Cement (1) | Surface Sealed (1) | Low Damage (1) | Usually inaccessible or unlikely to be disturbed (0) |

| <b>Recommendation</b> | Manage and re-inspect | | | | | | |
